YATES MEMORIAL HOSPITAL

KETCHIKAN ALASKA

HISTORIC BUILDING ASSESSMENT

REVIEW DRAFT: SEPTEMBER 2013

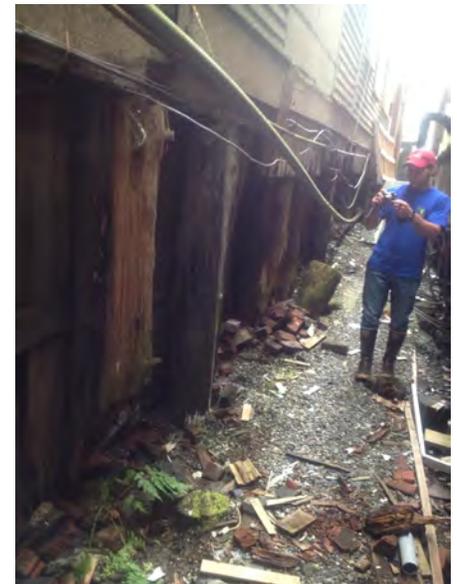
Brett Serlin of Tongass Engineering conducting a walkthrough and preliminary evaluation of piling conditions along the west wall of Yates Memorial Hospital.

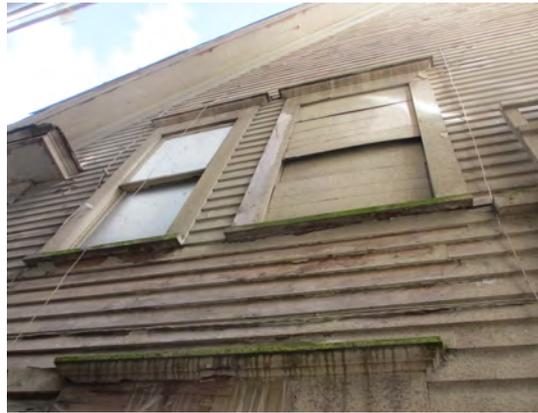
On the west facade, the original cedar siding was not clad in vinyl but received a treatment of sprayed-on plastic material. All of the original fenestration detailing remains. This elevation is protected from the elements and shows little deterioration.

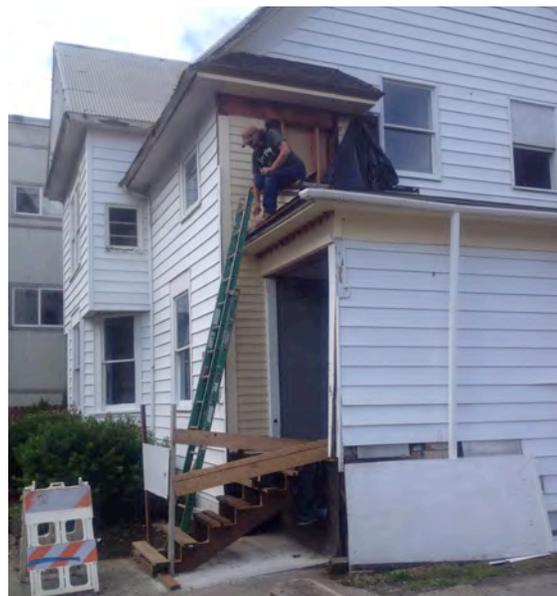
As shown in this August, 2013 photo, the east and south (Mission Street) elevations have a vinyl siding cover added in the 1970s. As part of the historic building assessment, a portion of the vinyl siding was removed to expose the original cedar siding and determine its condition for restoration. The original siding is still in excellent condition and needs only minor repairs.

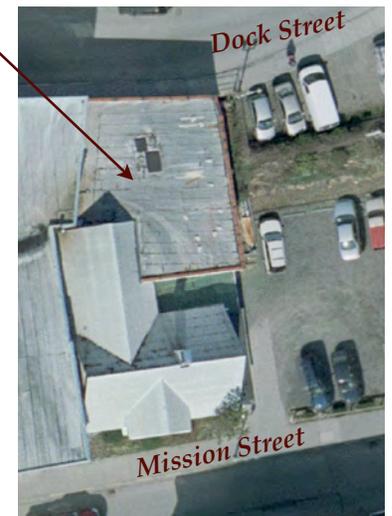
The only visible remaining portion of the Yates Memorial Hospital’s north elevation is the gable and a portion of the 2nd floor elevation as shown in aerial view. The Tobin Building immediately abuts the Yates structure and conceals the remaining elements of the north facade. The original interior space was not compromised by the addition of the Tobin Building.

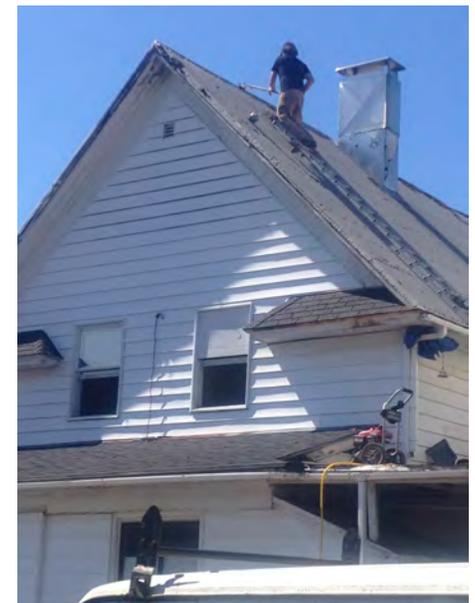
Historic Ketchikan recently re-fastened the aluminum roof to extend its life. There are several bends and creases in the roof skin, however none that allow entry of rainwater. The chimney flashing has been resealed and the gutter/downspout system is being repaired.

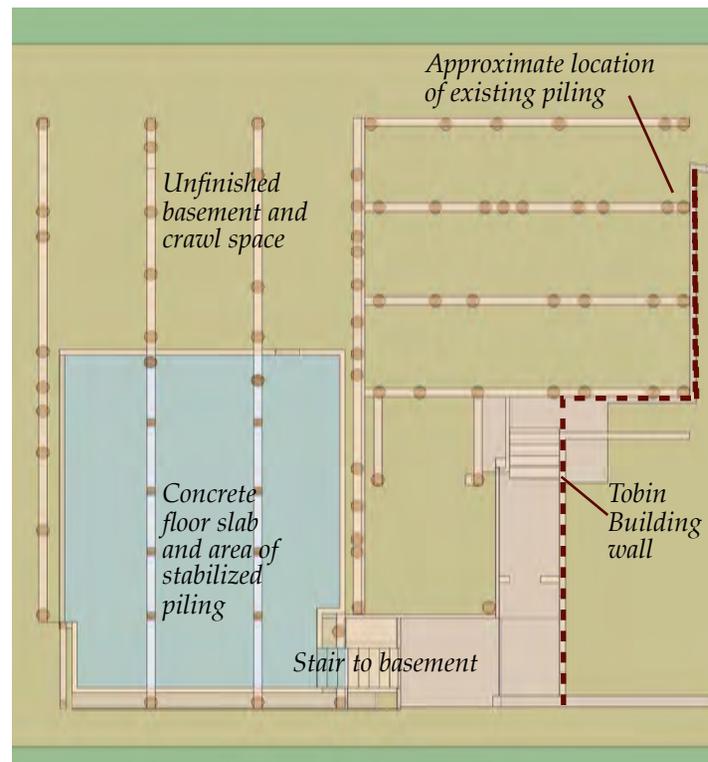
The above foundation plan illustrates the basement/crawl space conditions. The round piling symbol shows the extent of remaining piling--virtually all of which must be replaced. The adjacent Tobin Building is built on a concrete slab.

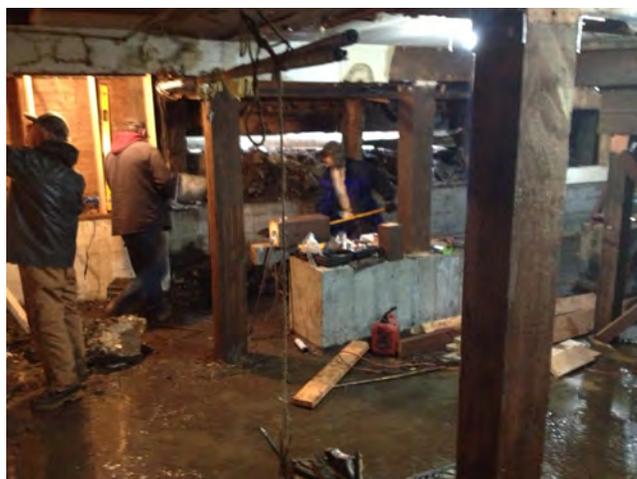
Historic Ketchikan recently completed a temporary stabilization project in the partial basement area. A shear wall was installed on the existing concrete stub walls and 8 new piling were installed with steel angles connecting the piling to the piling caps.

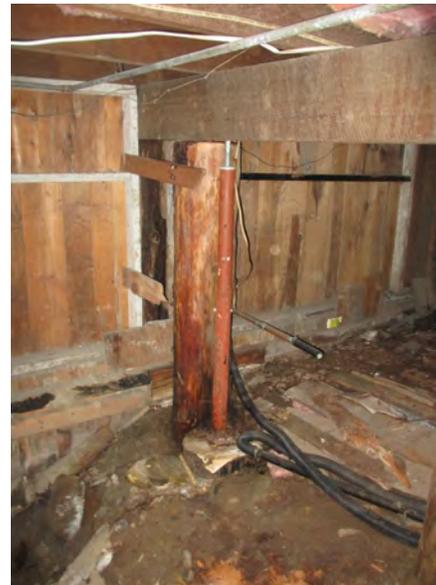
The log posts supporting much of the building are significantly deteriorated. In many cases, they have been augmented by screw jacks, as shown here. The 8x10 heavy timber piling caps are in generally excellent condition.

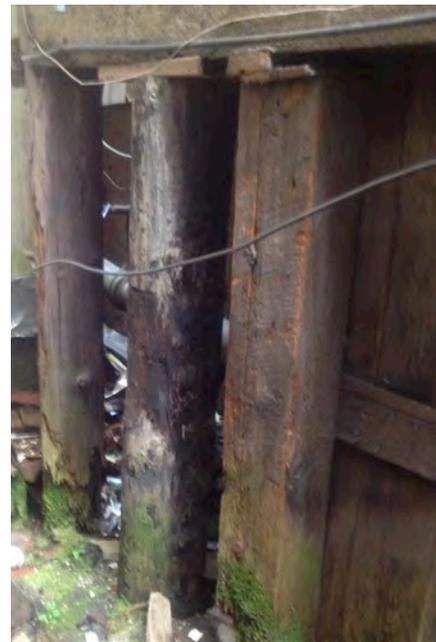
Piling conditions at the west elevation. In this case (and it is typical), a new creosote pile was placed between two adjacent deteriorated piles to carry the building load. There is no attachment between the piles and the cap.

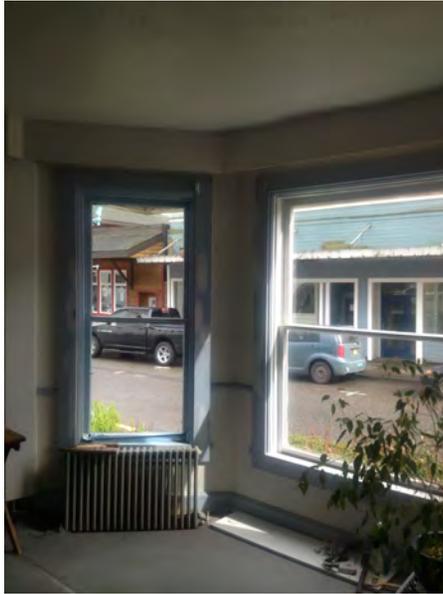
As one of Historic Ketchikan's first stabilization steps, the bay window on the first floor required immediate repair. The glass in the lower sash of the large double-hung, bay window (on the right) had been broken for a significant period and only partially covered with plywood allowing moisture to enter the building. In this case, the sash had to be removed and repaired. The bottom rail was significantly deteriorated and this required splicing new wood into the existing member and then sealing, priming and painting the sash and replacing the glass.

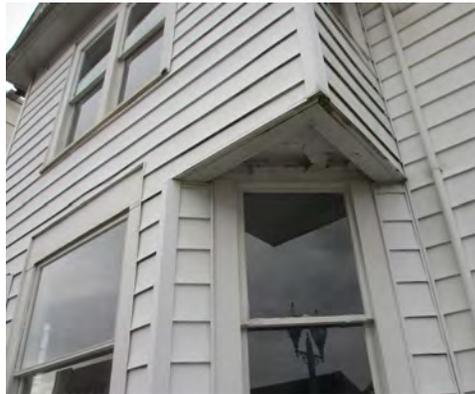
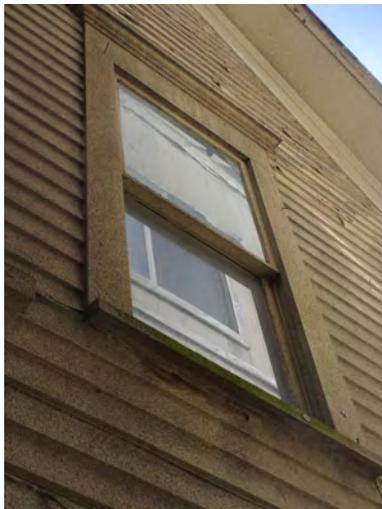
On the west facade, protected from the weather and remodelers, all historic windows remain in the various configurations occurring on the other facades, and all detailing is intact. These windows can serve as the model for replacing any of the period details on the south and east facade windows.

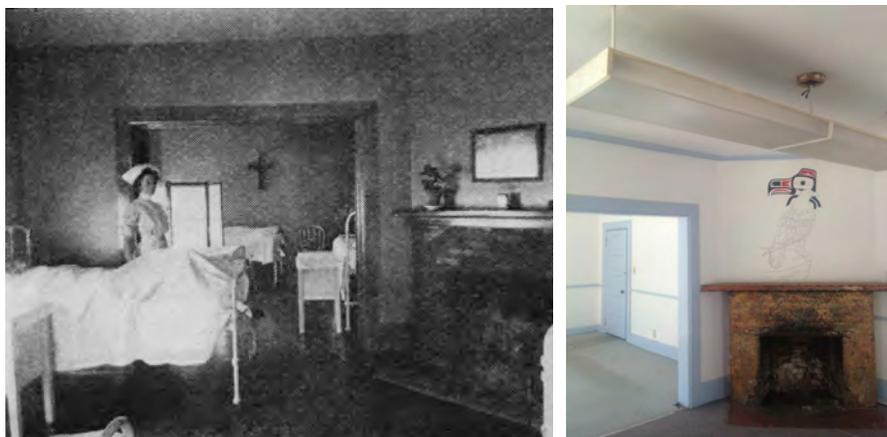
The same fireplace prominent in the 1912 "Spirit of Missions" photo remains today in the first room just inside the entry from Mission Street. It still functions but will require masonry work on the hearth and firebox.

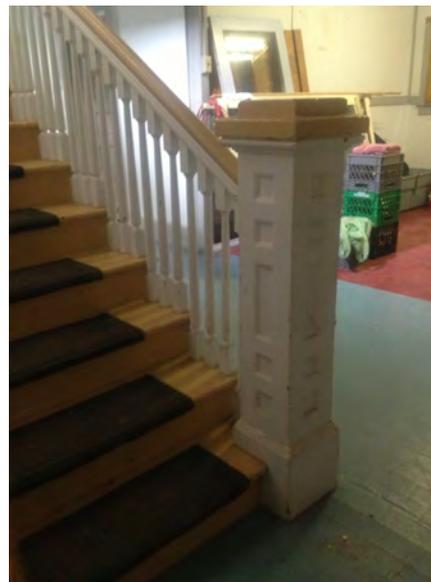
The staircase is one of the special interior architectural elements. It had been treated as an art form: handsome embellished newel posts, turned balusters, strong handrail, and coats of many colors. All staircase elements remain in excellent condition.

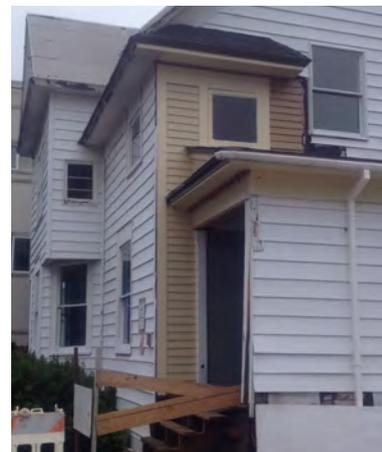
In this recent photo of the entry area, the historic siding (in light colors) was restored. In this area, most of the siding was in excellent condition. Proposed paint colors have been applied to the siding and corner trim.
