YATES MEMORIAL HOSPITAL

KETCHIKAN ALASKA

HISTORIC BUILDING ASSESSMENT

REVIEW DRAFT: SEPTEMBER 2013

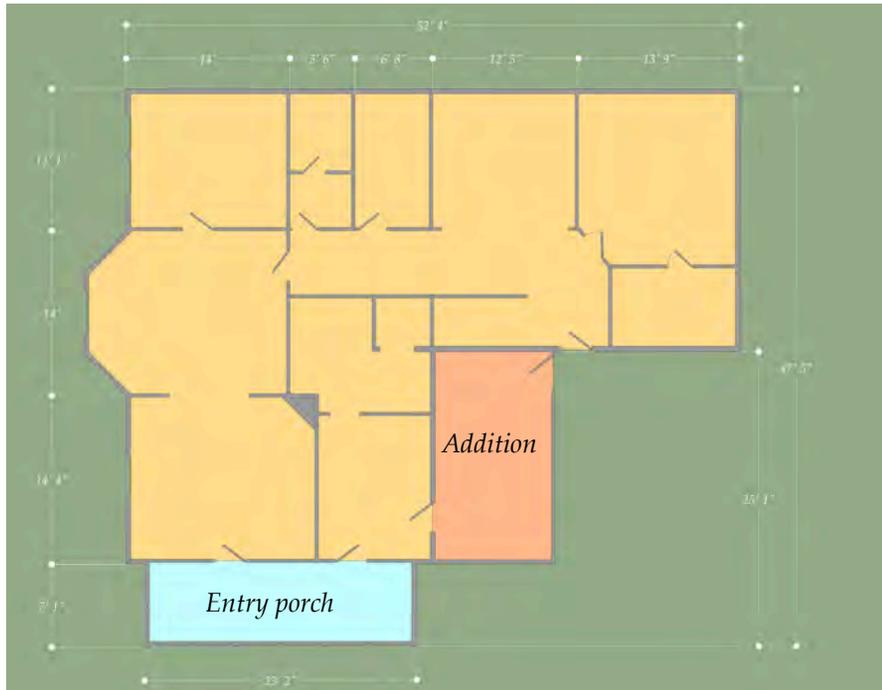
The first and second floors total approximately 3,600 sf. A central staircase serves the second floor. There are two entries: one on the Mission Street elevation and one on the east elevation. The light blue in the first floor plan indicates the entry porch area; the red-orange indicates a room added to the building in 1946.

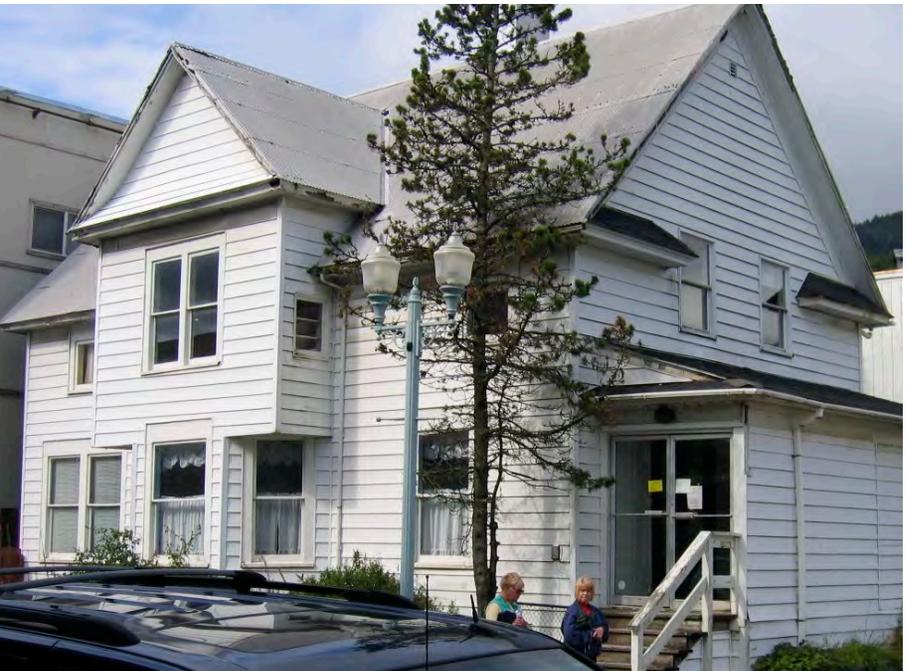
The south and east facade fenestration in 2012

In spite of nearly 110 years of exposure to Ketchikan's predominant southeast winds and rains, most of the windows on the south facade are in repairable condition. Each one of the window units was evaluated as part of this existing conditions survey. In most cases, some form of window decay has occurred resulting from lack of regular maintenance and resulting entry of moisture. In some cases, water has entered around the edge of the frame and the glazing putty has been cracked or partially missing allowing water to saturate the wood.

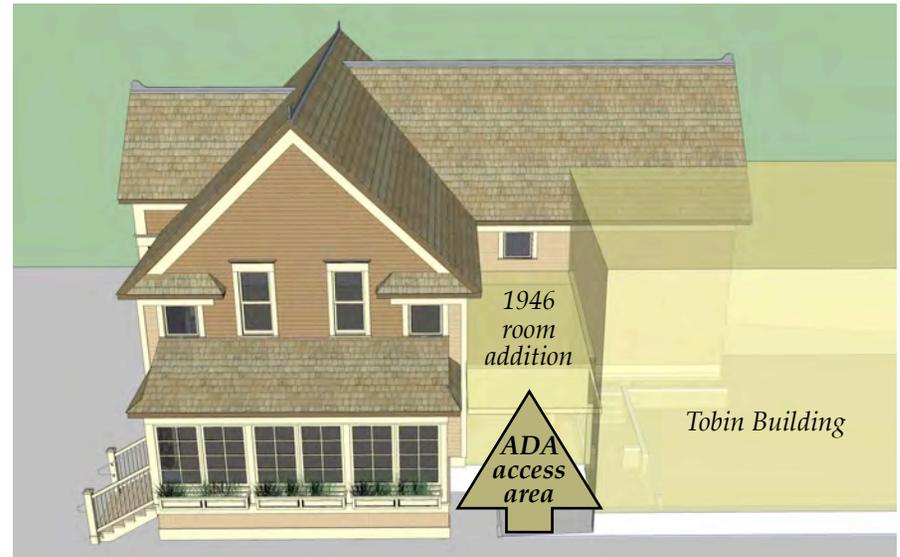
In considering the existing and required level of accessibility, it is clear that there is not an accessible entry available (the first floor level is approximately 42” above grade and sidewalk level). A ramp will be required that will need to be approximately 42’ in length to meet ADA slope requirements. This will be a difficult accessibility requirement to meet given existing configurations of entry doors, interior corridors, public restrooms, and other barriers.

This model illustrates a likely option for ADA access entering the building from the boardwalk on a ramp configuration that could enter the building at the north end of the restored entry porch.

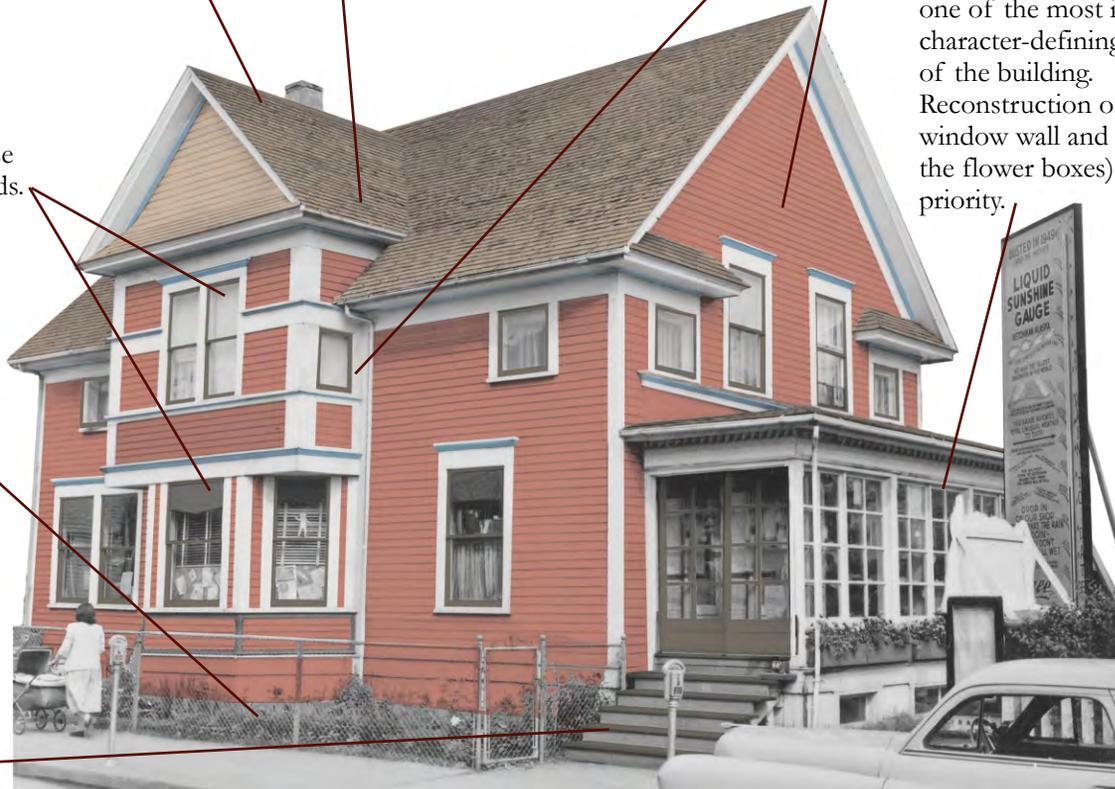
While the porch structure remains, the French doors and window wall (shown below) have long been removed. This feature is one of the most important character-defining elements of the building. Reconstruction of the window wall and doors (and the flower boxes) is a priority.

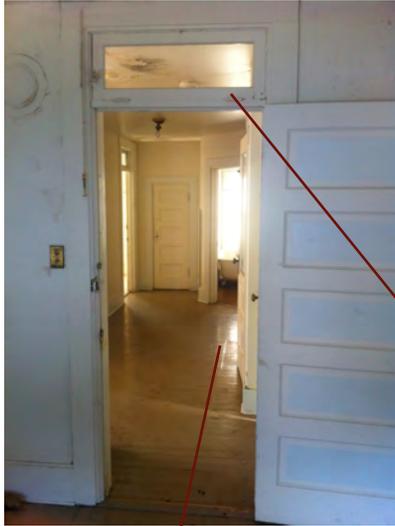
Flooring

The original vertical grain fir flooring (2-1/4" face) used throughout the building remains in good condition and is exposed in most areas except bathrooms and kitchens and where carpet has been applied.

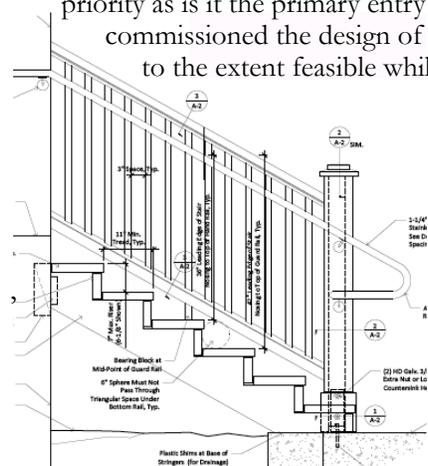
This design was prepared by Historic Building Report team member Welsh/Whiteley Architects. It is designed to reflect the historic entry stair while also provide for code-required safety railings and present dimensional requirements for stair treads and risers, railing height, etc.

Virtually all key historic features of the primary facades have been retained over the life of the building with two key exceptions: the Mission Street entry stair and the entry porch (restoration of the entry porch is addressed under the Windows & Doors Recommendations on p 35). The entry stair is an early priority as is the primary entry point to the building. Historic Ketchikan commissioned the design of the entry stair to match the historic stairs to the extent feasible while meeting current building codes.

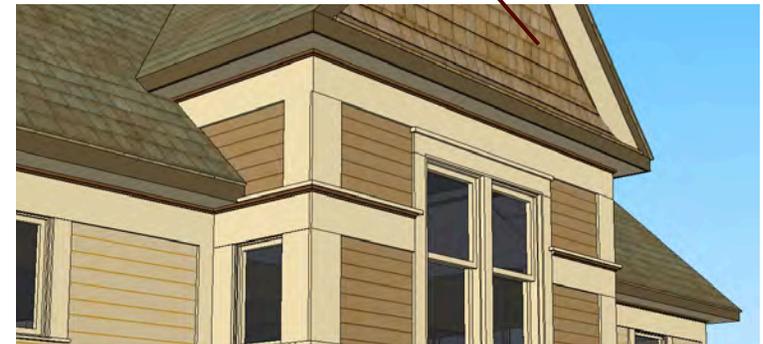
This is one of the character-defining elements on the primary Mission Street facade. The existing shingles (under the plastic siding) may be able to be repaired and restored depending on their condition.

- **Restore the shingled gable above the bay window on the Mission Street facade.**

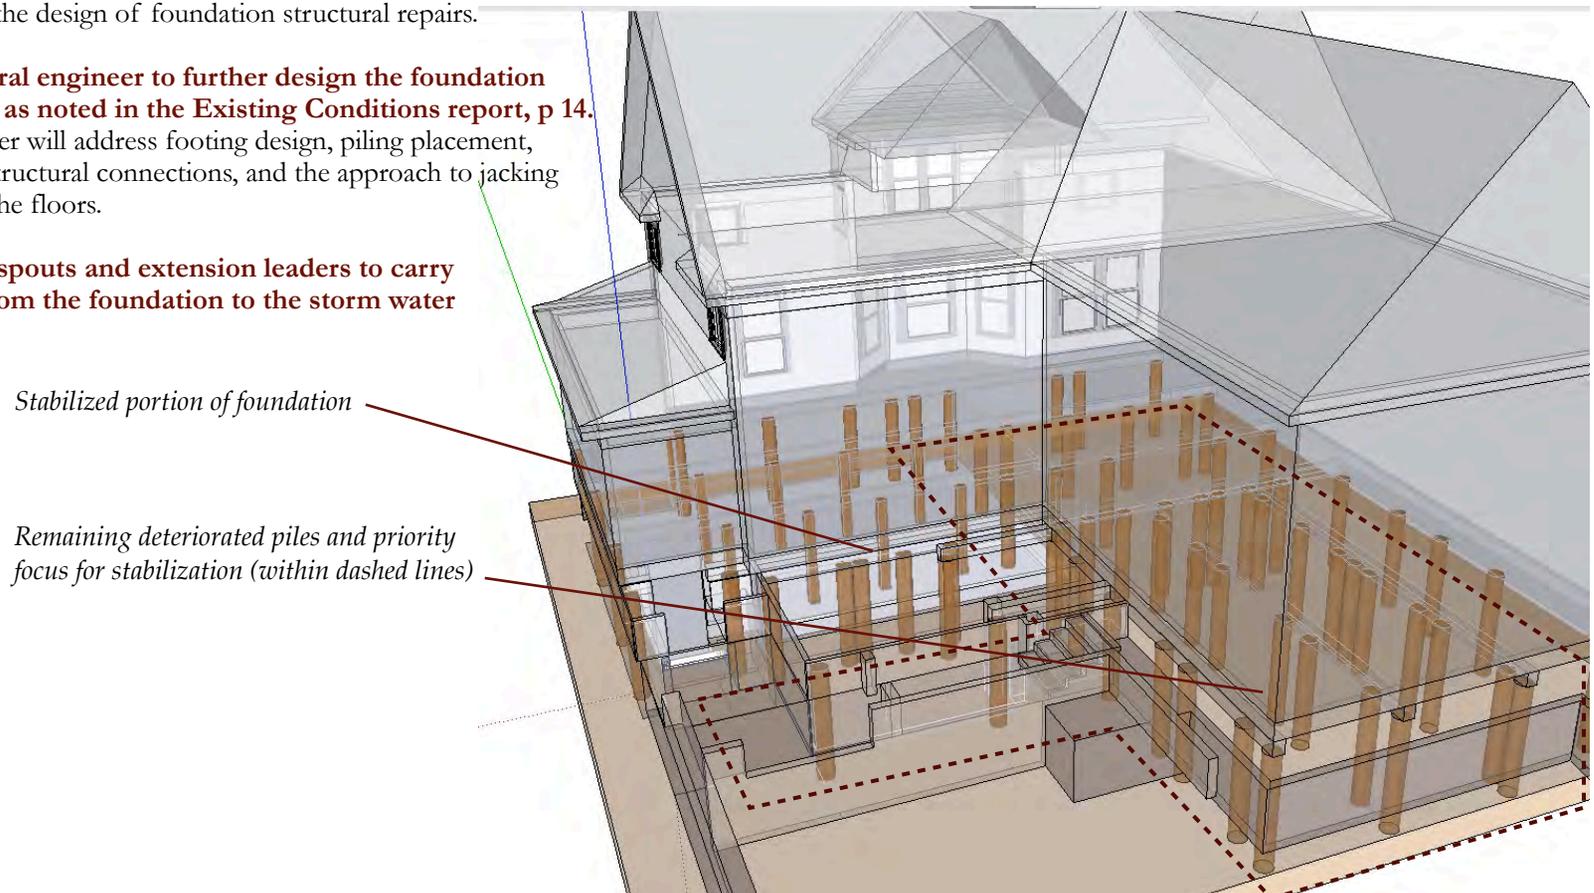
This is the priority restoration requirement. Historic Ketchikan has stabilized approximately 20% of the foundation support system. Stabilizing the remaining, deteriorated piling system represents an immediate need. This will require removal of rotted, crawl space wall materials and other debris; securing the perimeter with fencing; and installing temporary, braced pilings on spread footings in a manner that allows for removal of existing, deteriorated piles and installation of permanent footings and piling support system.

Virtually all of the piling caps inspected are in excellent condition. In two cases, there has been deterioration and these two locations should be addressed as part of the design of foundation structural repairs.

While Historic Ketchikan and its volunteers can clean up and do prep work, a local contractor with building moving and piling reconstruction experience is a must. Since the building has settled as much as six inches at the west wall, the entire building will need to be jacked incrementally to approximate level. This will be done in conjunction with new foundation pilings, footings and bracings.

- **Stabilize the building with temporary foundation supports.**

- **Inspect any areas of deterioration of piling caps and replace as necessary.**

- **Engage a structural engineer to further design the foundation structural repairs as noted in the Existing Conditions report, p 14.**

- **Install new downspouts and extension leaders to carry rainwater away from the foundation to the storm water system.**

- **Implement structural repairs with a qualified, local contractor experienced in similar projects in Ketchikan.**

- **A moisture barrier should be installed over the unfinished portions of the basement/crawl space**

This measure would keep moisture from wicking up through the dirt floor.

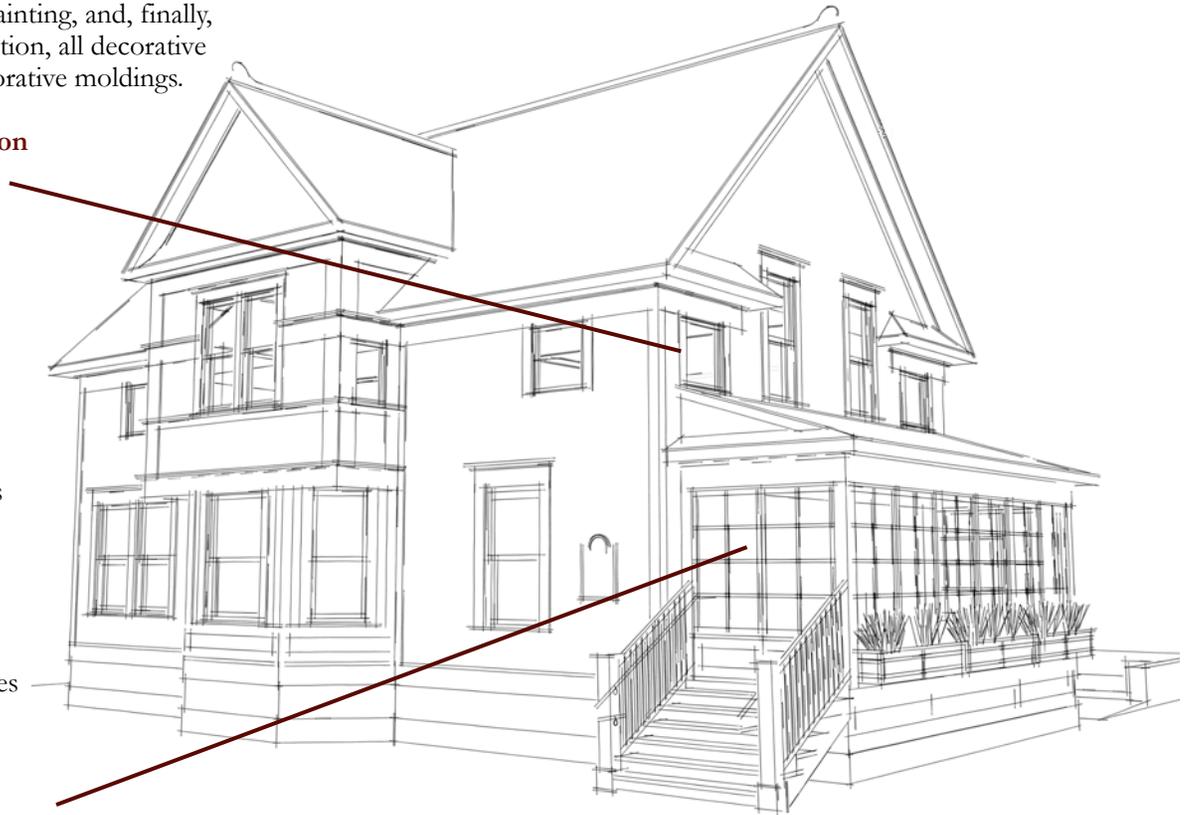
While wood windows are renewable over an indefinite period of time with proper care and maintenance, decades have passed at Yates Memorial Hospital with little attention paid to the windows. The sashes have often been painted shut, ropes are broken or frayed, the paint and putty have deteriorated, the hardware may be broken or missing and the wood may be rotted or damaged. The work ahead is to repair and restore window frames and sashes showing evidence of surface cracking and rot. It will require pulling the sash, repairing the sills and frames in place, protecting the historic glass, re-glazing after repairs to the frames and sashes, painting, and, finally, reinstallation with appropriate weather stripping. In addition, all decorative features will be restored, including hood molds and decorative moldings.

Four second floor windows on the east elevation were removed entirely or replaced by non-historic windows. The two center double-hung windows will need to be replaced by double-hung windows identical to the originals. There remain several double-hung windows of the same dimensions on the west facade of the building that can be used as models for matching the historic windows. Similarly, the two low, casement windows on either side of the double-hungs must be replaced, once again using as a model the same windows on the west facade.

While the entry porch structure remains, the distinctive multi-paned windows surrounding the three exterior sides of the porch have been removed. As one of the most important character-defining features of the building, restoring the porch window wall and entry doors are an early priority. Restoration drawings will be prepared for fabrication of the replacement windows to match the exact proportions of the historic porch. As part of design development, consideration will be given to using insulated glass windows as an energy conservation measure if the historic sash and mullion proportions can be maintained. French doors at each end of the porch are key entry points to the building; on one side, from Mission Street and, on the other, for an ADA access point of entry.

While old single-pane glass windows can be a major source of heat loss, adding a wood storm window can approximate the R-value of an insulated glass replacement. Much of the heat loss of the present historic windows will be reduced by caulking gaps around the sashes, replacing loose, broken or missing glazing compound, and installing window stripping.

- **Retain and restore all exterior historic windows.**

- **Replace missing exterior windows on east elevation with matches to the historic windows**

- **As part of overall energy conservation program, install storm windows at all locations**

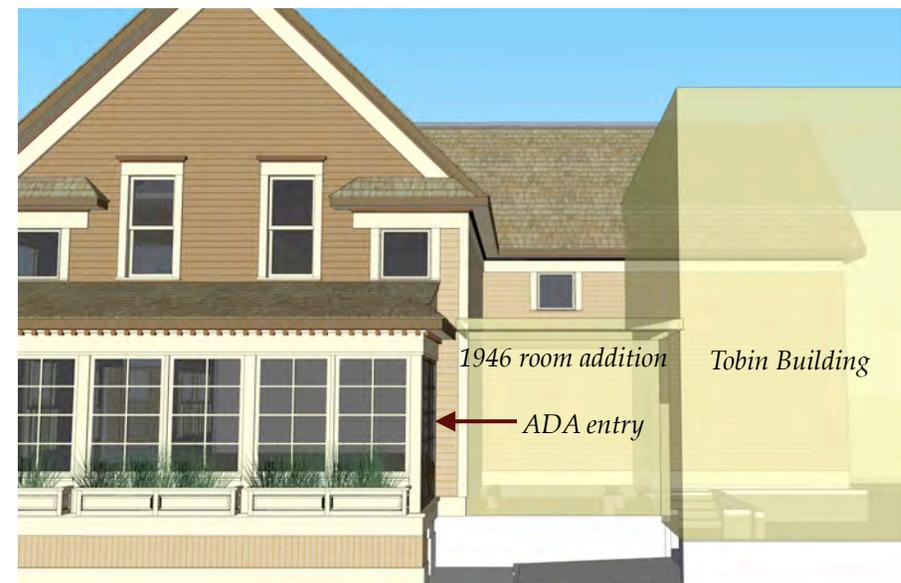
A key design challenge will be the access ramp required to accommodate the 42" differential between grade and first floor level. The planned boardwalk connecting Dock and Mission Streets may accommodate up to 12" of the rise required. A ramp would then connect the boardwalk to the north end of the entry porch utilizing the space now occupied by a 1946 addition to the historic footprint of the building. The sketch below indicates the area between the two buildings that can accommodate the ADA ramp. This solution would meet the spirit of the ADA objectives by enabling access through the primary public entrance to the building and it would do so without permanent damage to character-defining features. If this means of accessibility proves feasible, an accessible circulation route through the interior of the first floor can be accommodated. ADA access to the second floor will not be possible without installation of an elevator and this is not foreseen in the near future due to budgetary limitations.

- **Develop an accessible circulation route to and through the building, including dedicated handicapped parking and accessible entry.**

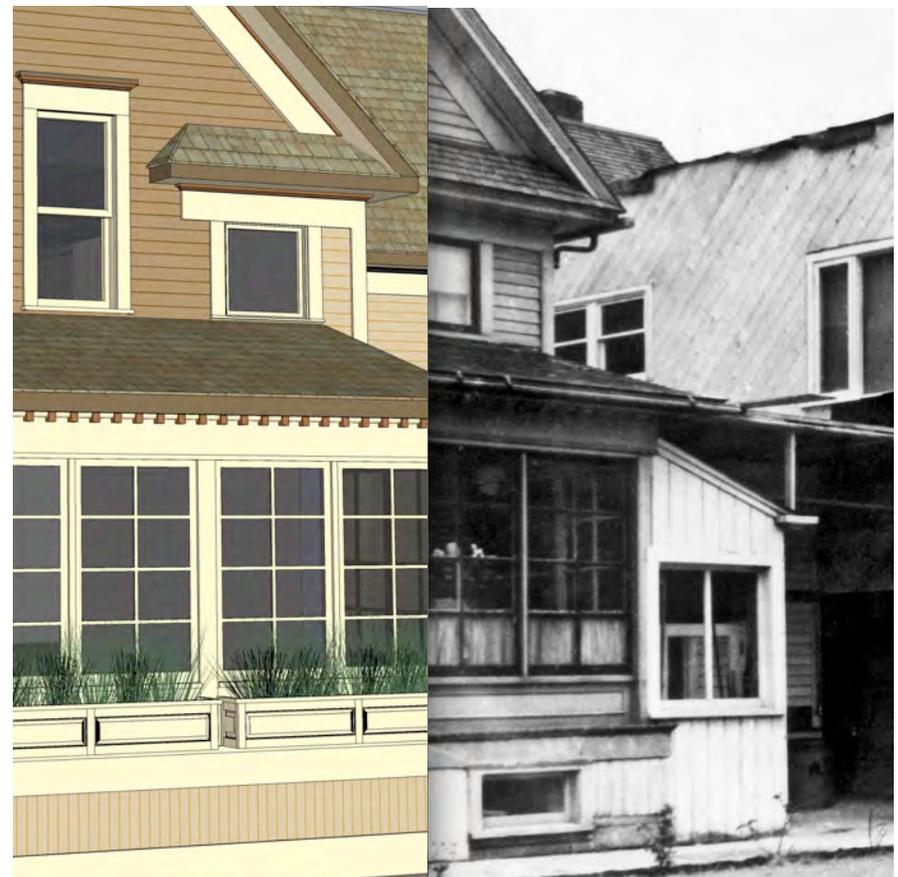
The historic building report team used historic photos and a digital model to develop reconstruction drawings. In this case, a 1946 photo (along with other earlier photos) helped us define the proportions of the window groupings along the entry porch.
